AKRON METRO RTA KENMORE BOULEVARD ADMINISTRATION BUILDING NEEDS ASSESSMENT REPORT

**October 19, 2015
Job No. 2015129.05**

AKRON METRO RTA
KENMORE BLVD ADMINISTRATION BUILDING STUDY
August, 2015

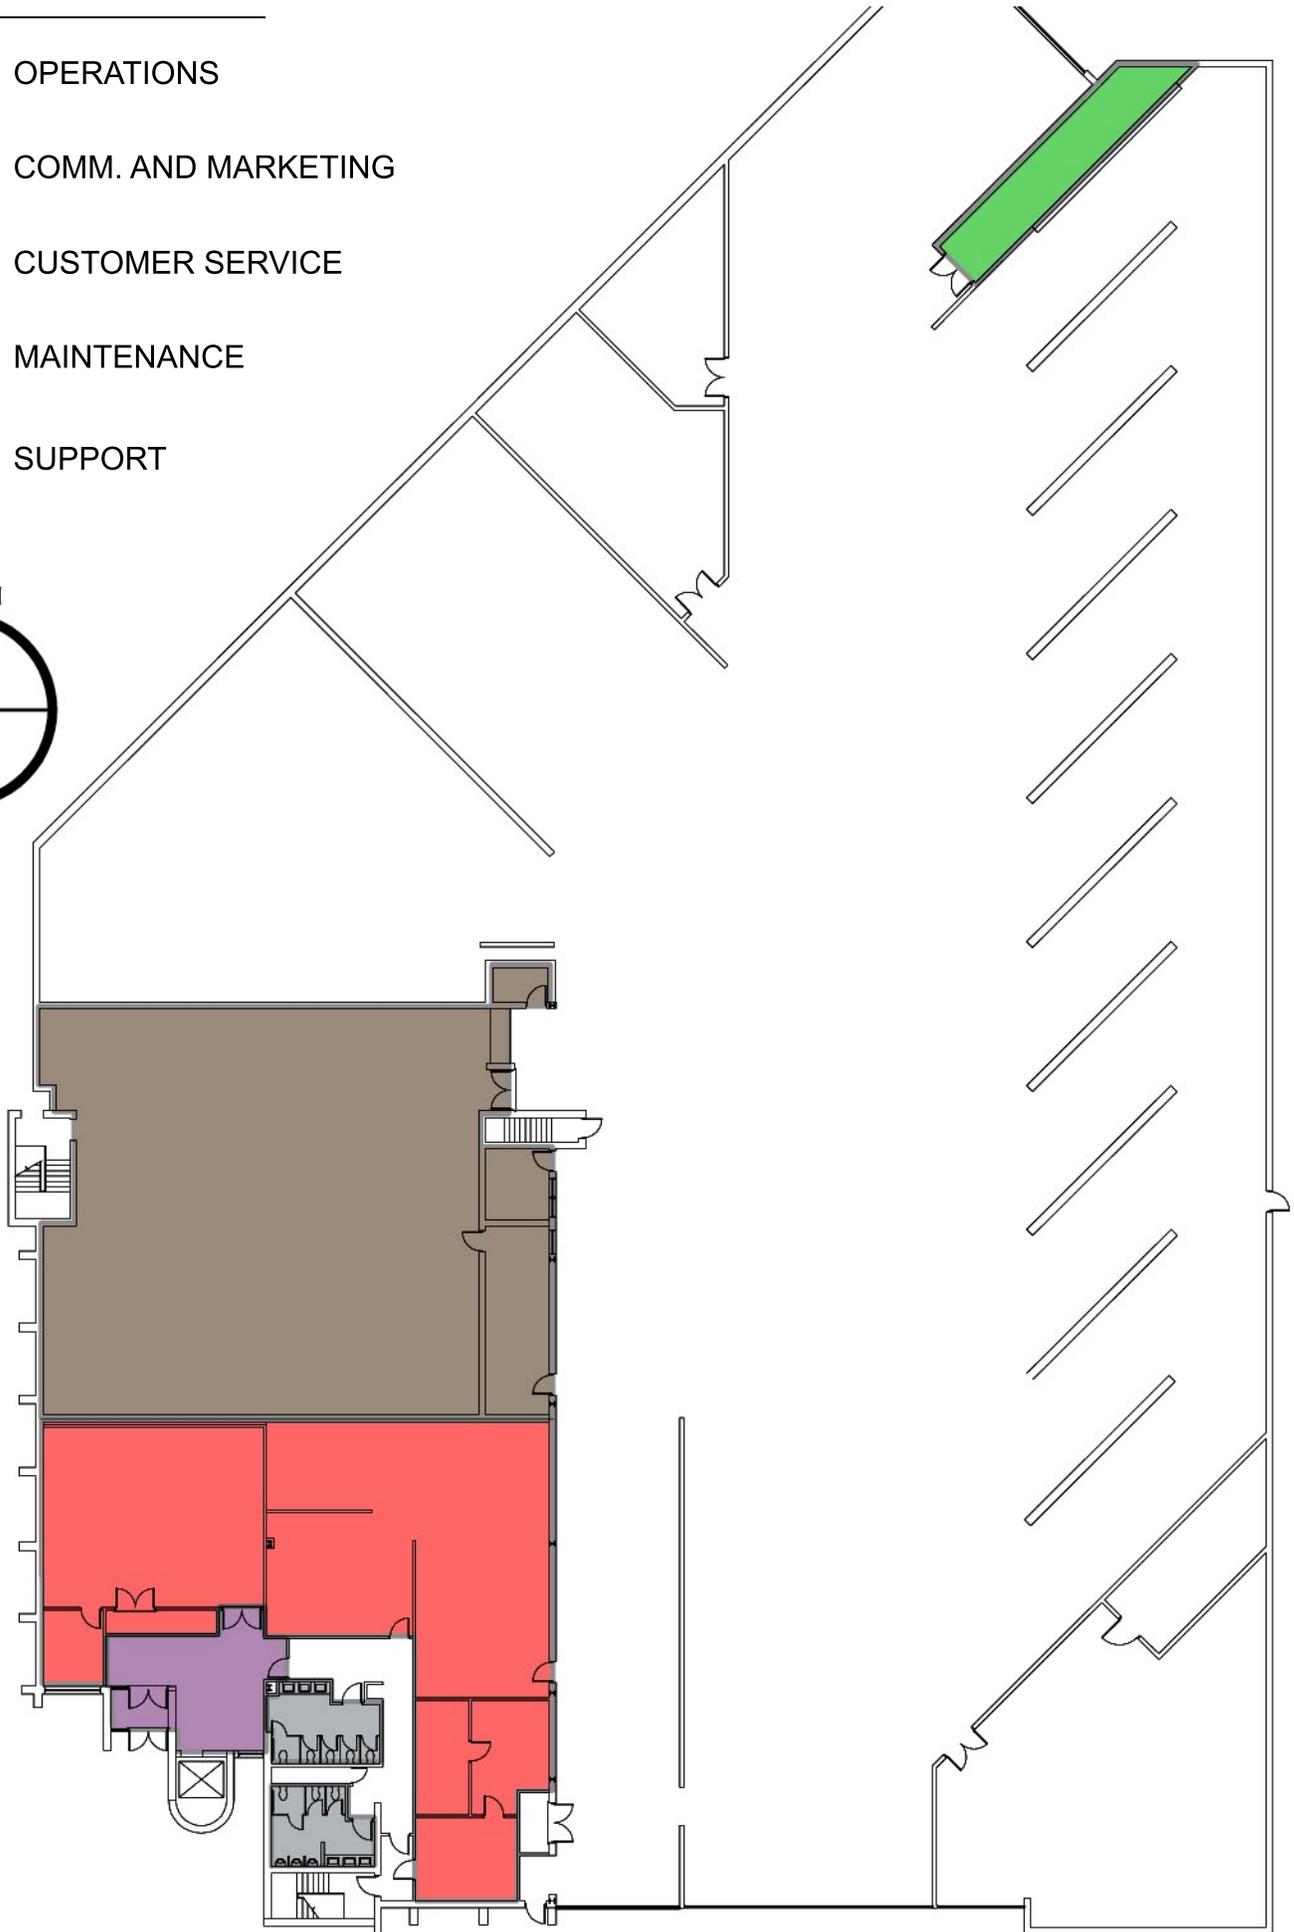
EXISTING MEZZANINE FLOOR - FP-2

The mezzanine floor is served by the elevator, two communicating stairs with the other floors as well as a stair leading directly to the maintenance shop, and houses the following:

- Customer service
 - Care Center (call center);
 - Office for Director of Customer Service;
 - Office for Assistant Director of Customer Service;
 - Mobility Office;
- Maintenance
 - Office for the Director of Maintenance;
 - Office for the Maintenance Administrative Assistant and Buyer;
 - Office for Maintenance Trainer;
 - Maintenance staff lunch room; and
 - Maintenance locker rooms, showers and toilet facilities for both men and women;
- Storage
 - Customer Service

- Maintenance
- Communications/Marketing

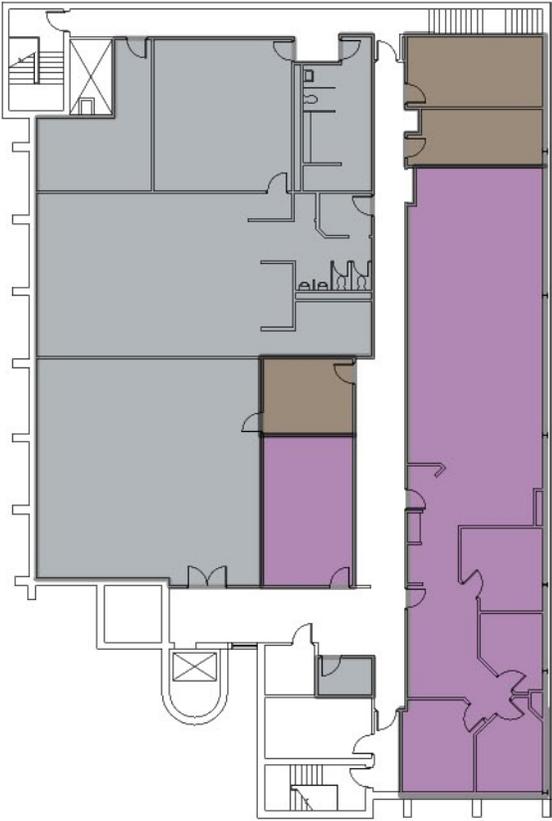
EXISTING SECOND FLOOR - FP-3

The second floor is comprised of the remainder of the administrative functions of the organization and is served by the elevator and two stairwells. The second floor was remodeled in 2009 with an improved layout of offices and support space. It currently houses the following:

- Executive
 - Board Room
 - Office for the Executive Director/Secretary/Treasurer
 - Office for the Executive Director's Administrative Assistant
- Finance

- Office for the Director of Finance/Assistant Secretary-Treasurer
 - Office for the Chief Accountant
 - Office for the Accountant
 - Office for the Procurement Manager
